## **Diagnostic Testing of an 830 MWg Utility Boiler**

On September 7 and 8, 2006 STEP Combustion performed combustion testing and economizer outlet emissions mapping of an 830 MWg Utility Boiler (Unit #2). The testing was conducted in order to aid in the diagnosis of combustion issues which have resulted in limited generating capacity of the unit.

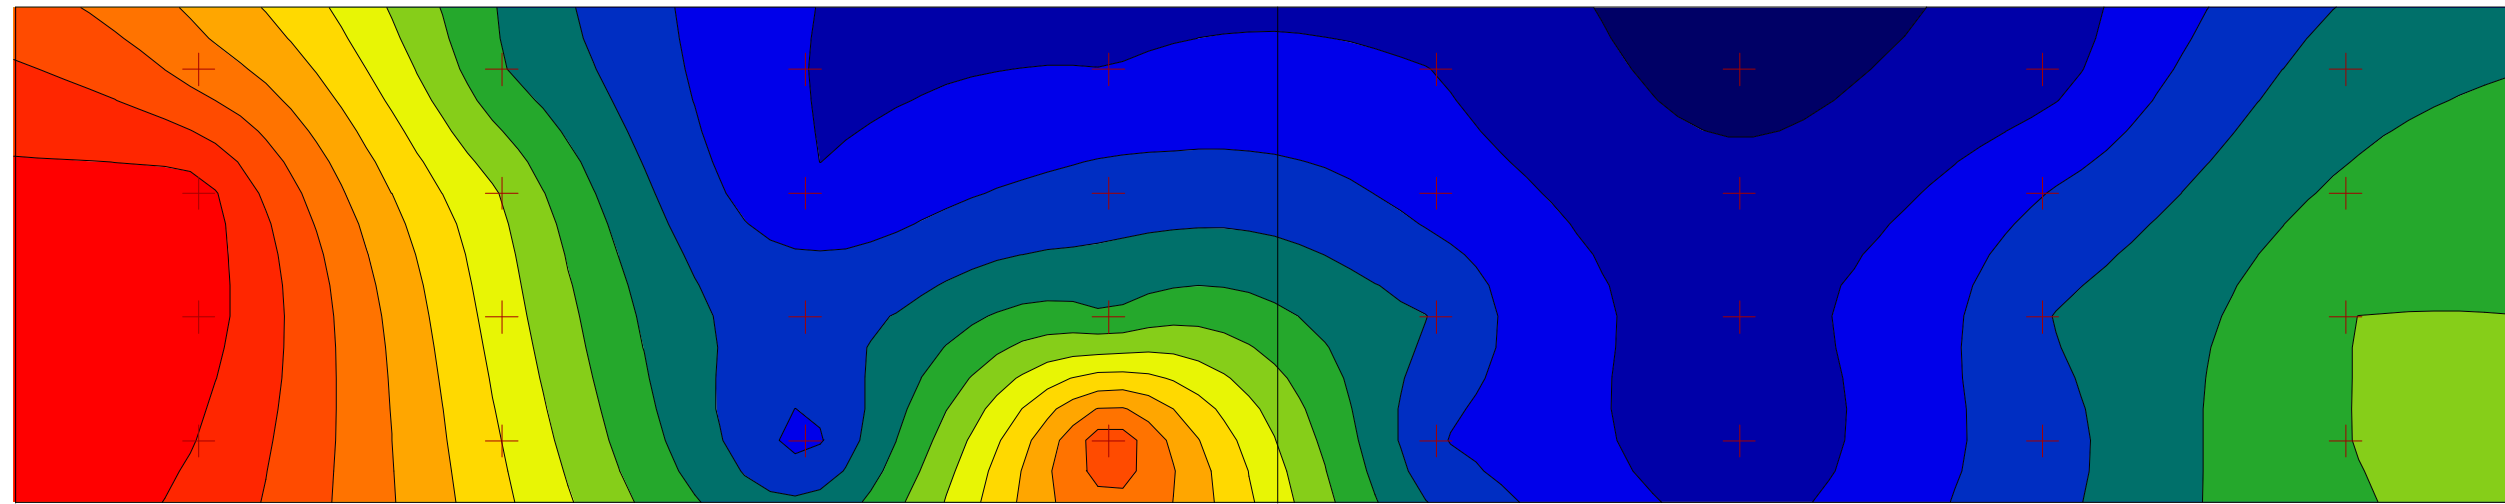
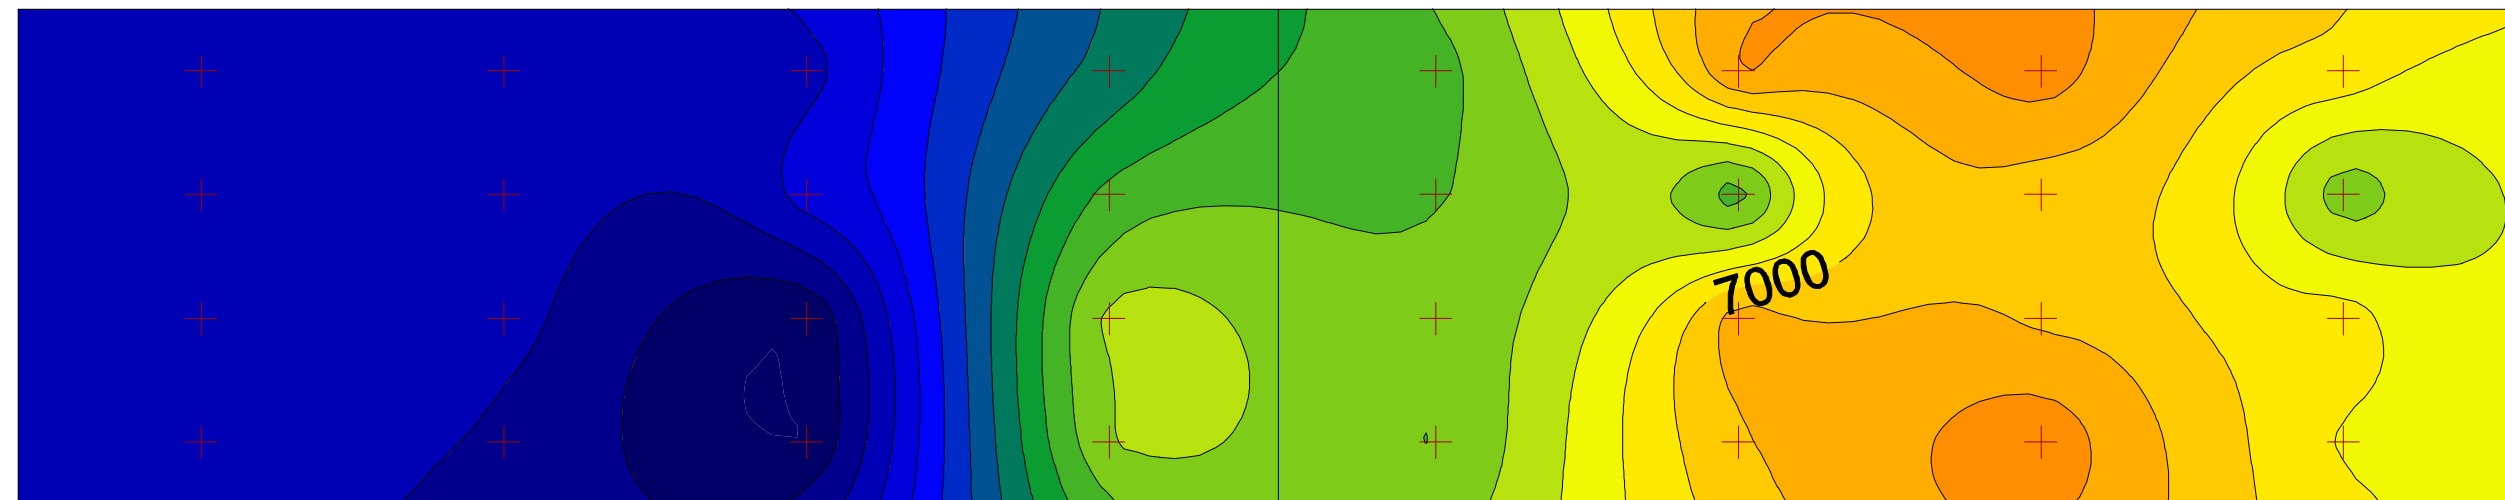
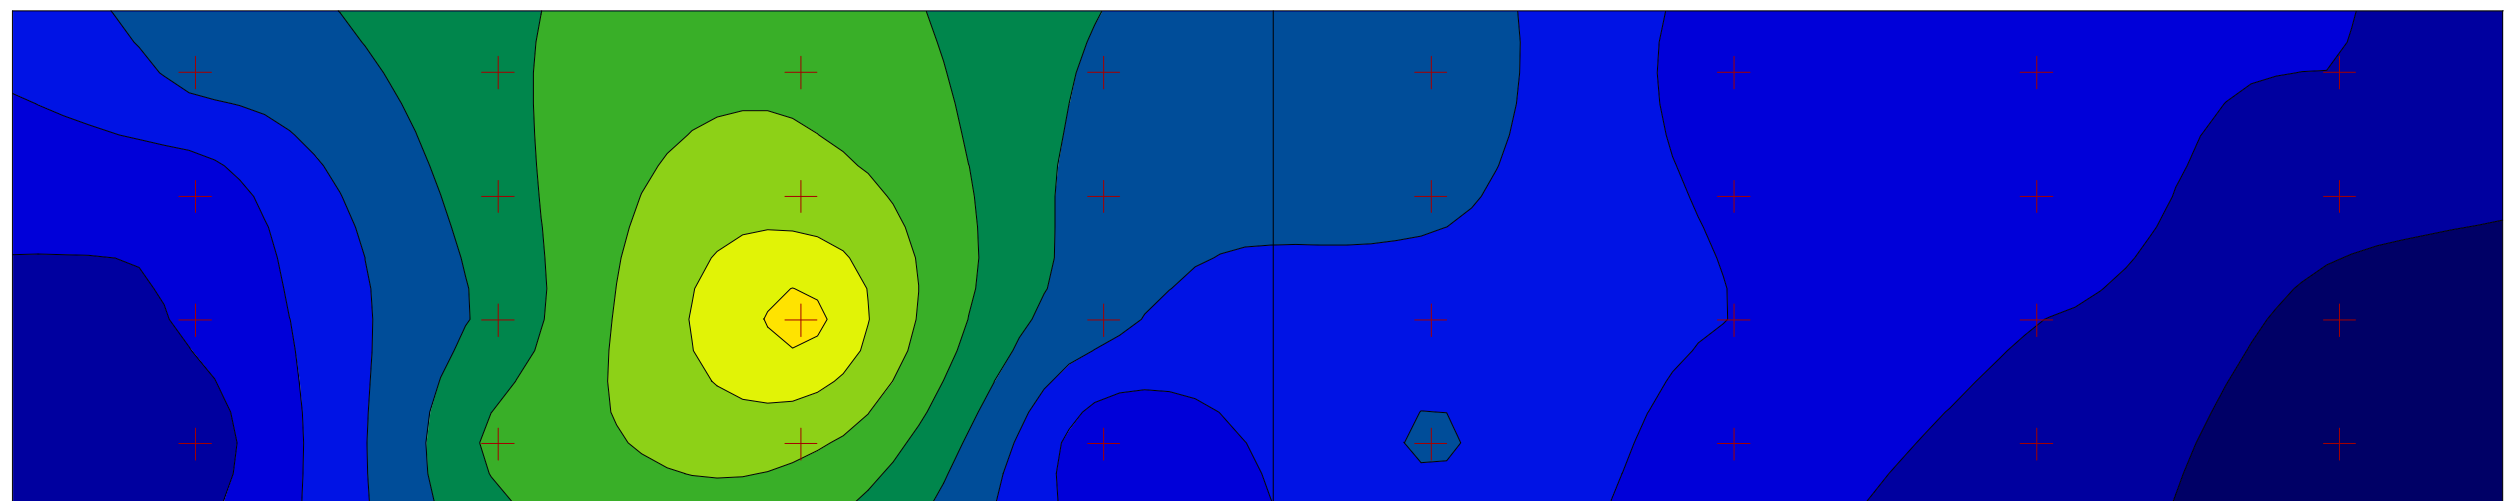
Testing began with a full economizer outlet emissions map and documentation of operating parameters under typical firing and operating conditions at a Full Load of approximately 786 MWn (Test No. 06907-1). Unit operating data were obtained, along with an economizer outlet emissions grid of O<sub>2</sub>, CO, CO<sub>2</sub>, and NO<sub>x</sub>. Emissions contour plots are provided in Figure 1 attached. As shown, it was observed that high CO emissions were characteristic across the economizer, however levels on the North duct were substantially greater. It was also noted that the unit is currently operating with known hardware problems in 3 of the 32 total burners. Problem descriptions are provided below:

Obviously, operating with no flame stabilizer or a severely damaged flame stabilizer can lead to significant combustion related issues. The flame stabilizer produces a low pressure zone along the centerline of the burner which induces a recirculation of combustion gases and results in a stable flame and good combustion characteristics. Without a flame stabilizer in good condition, injected fuel will disperse, uncontrolled, in to areas with little or no excess O<sub>2</sub> and the resulting incomplete combustion can carry-over to the boiler exit.

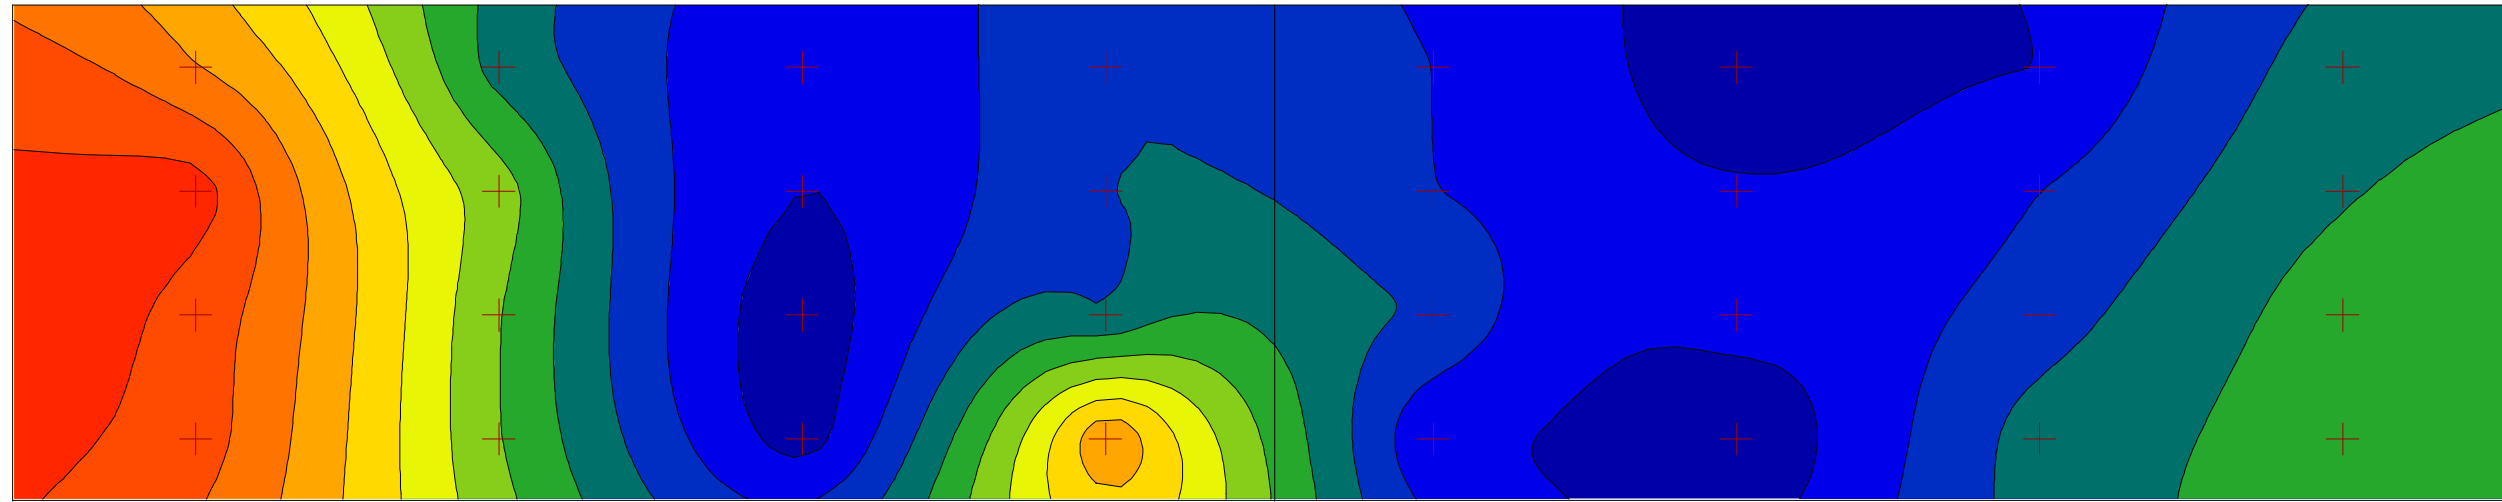
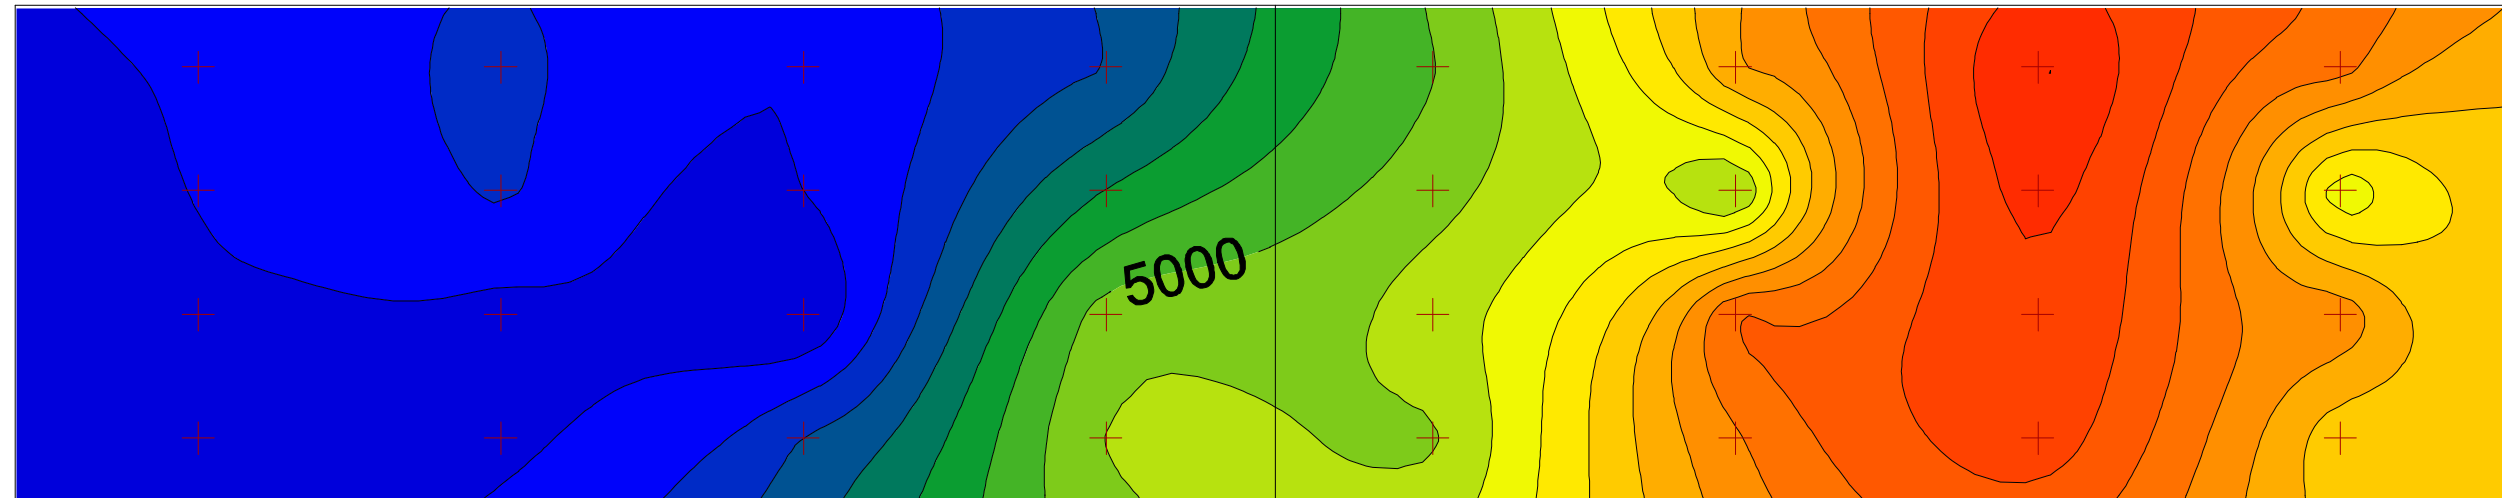
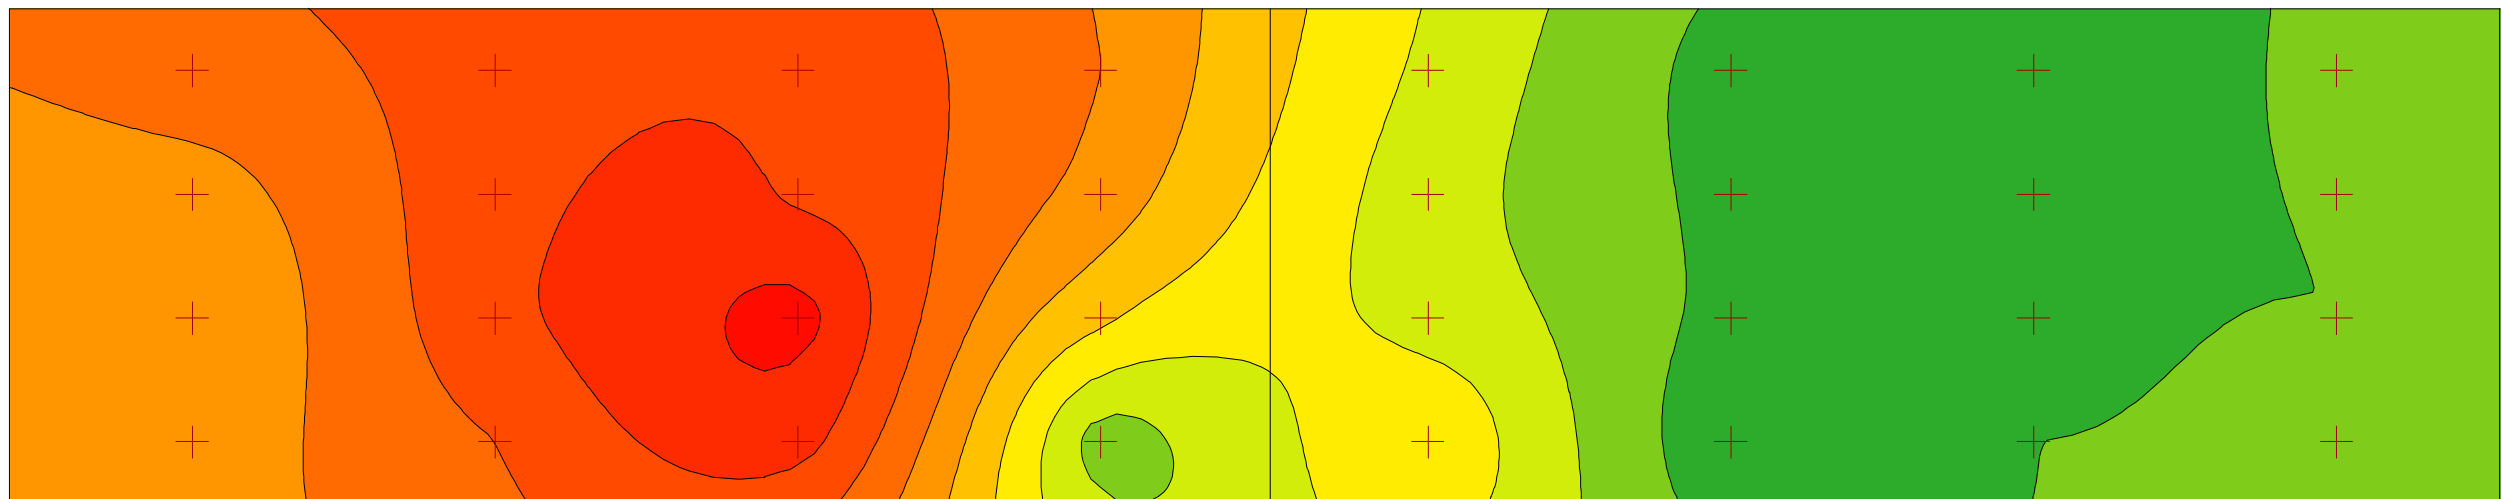
Figure 2

Subsequent to the initial test condition, the quantity of flue gas recirculation to the windbox was reduced (flue-gas-recirculation is controlled by the GI fan) and another full test was performed. The calculated quantity of flue gas recirculation was reduced from 15% for test 060907-1 to approximately 10% for test 060907-2. Economizer outlet emissions contours for test 06-0907-1 are provided in Figure 2, attached. A comparison of Figures 1 and 2 shows that the excess O<sub>2</sub> and CO contours remained essentially unchanged, while NO<sub>x</sub> increased along the entire duct cross-section.

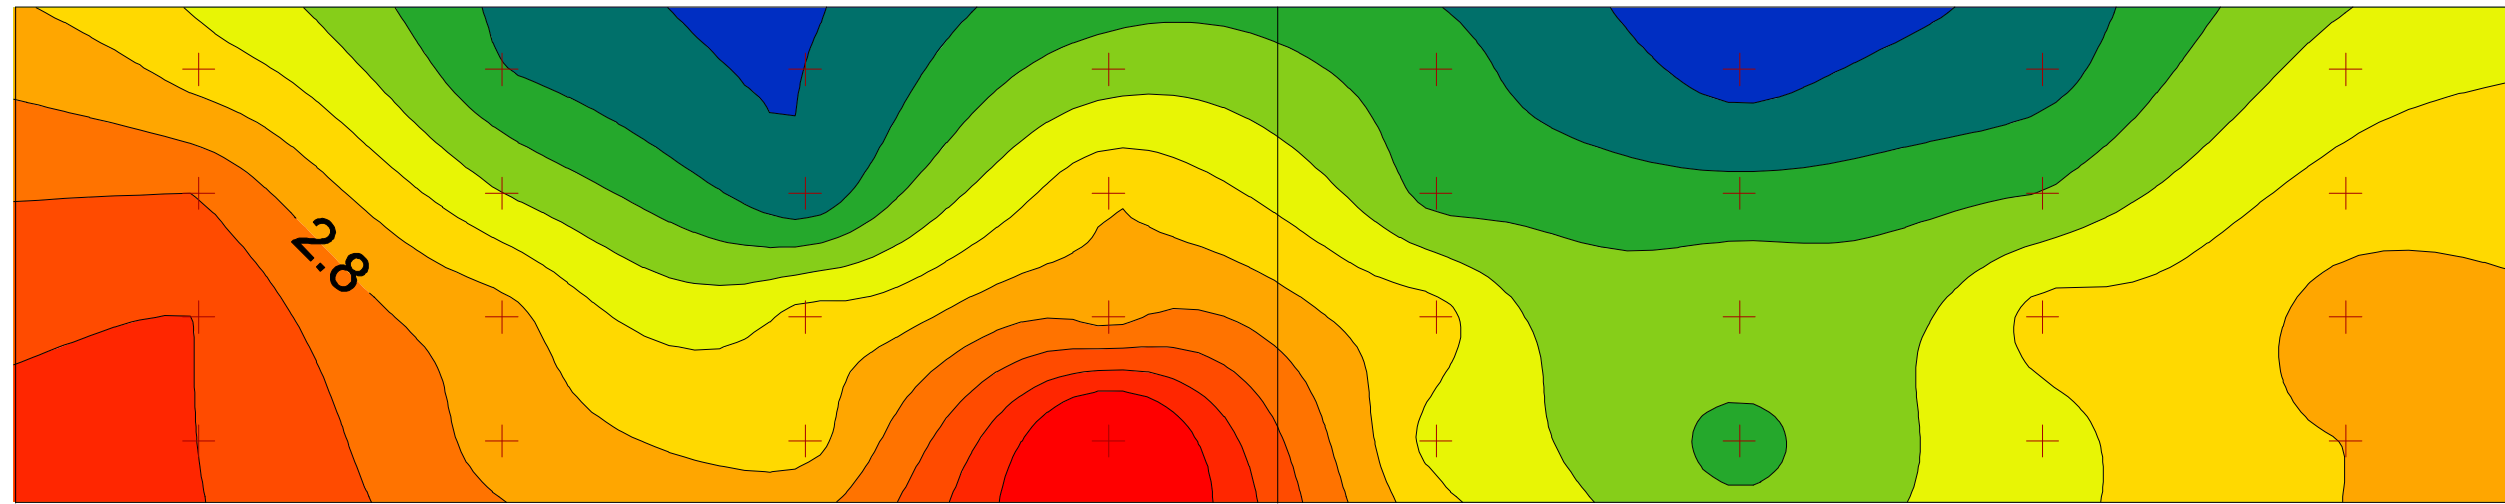
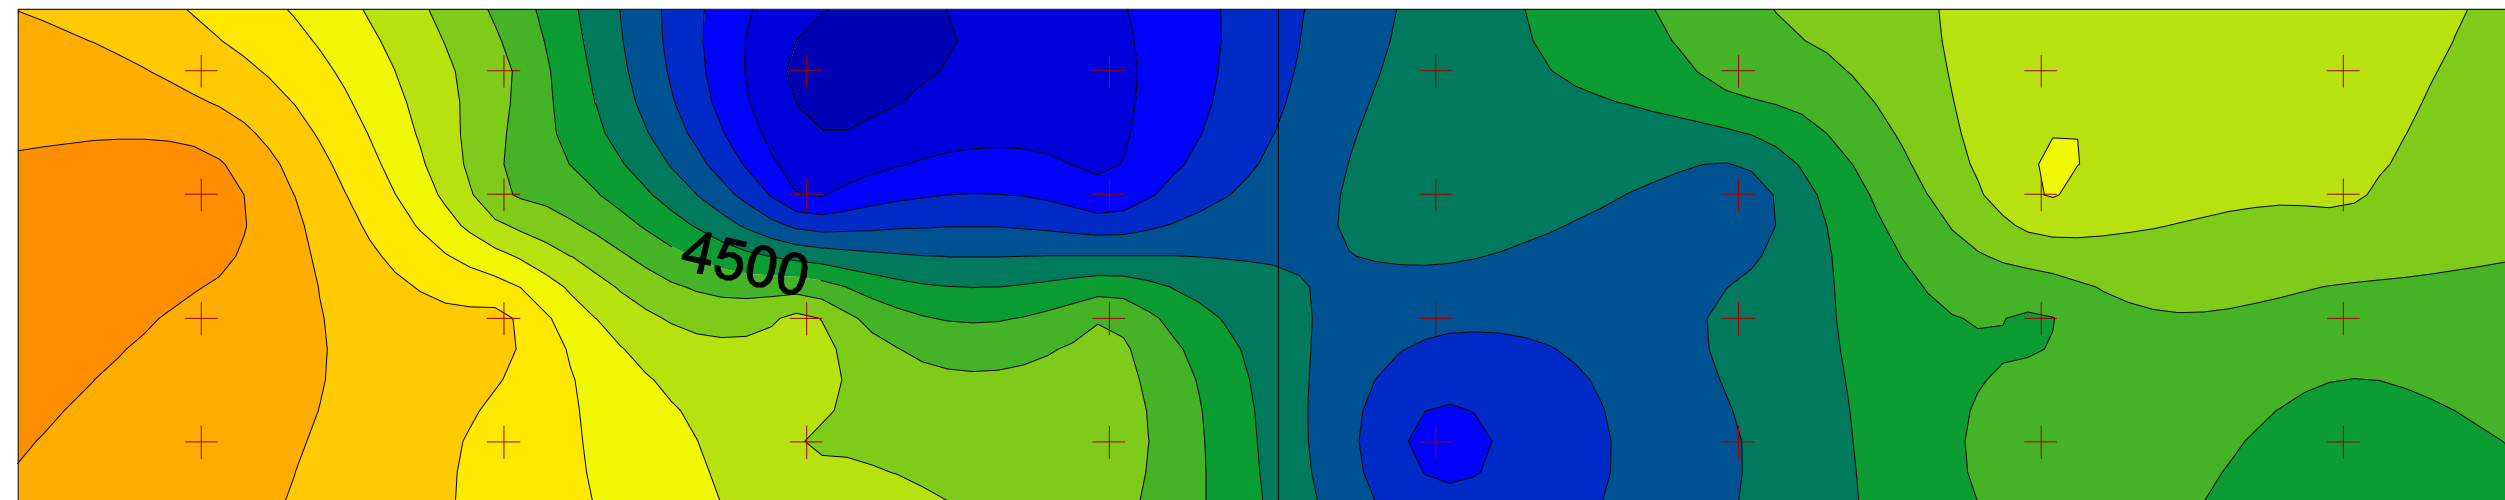
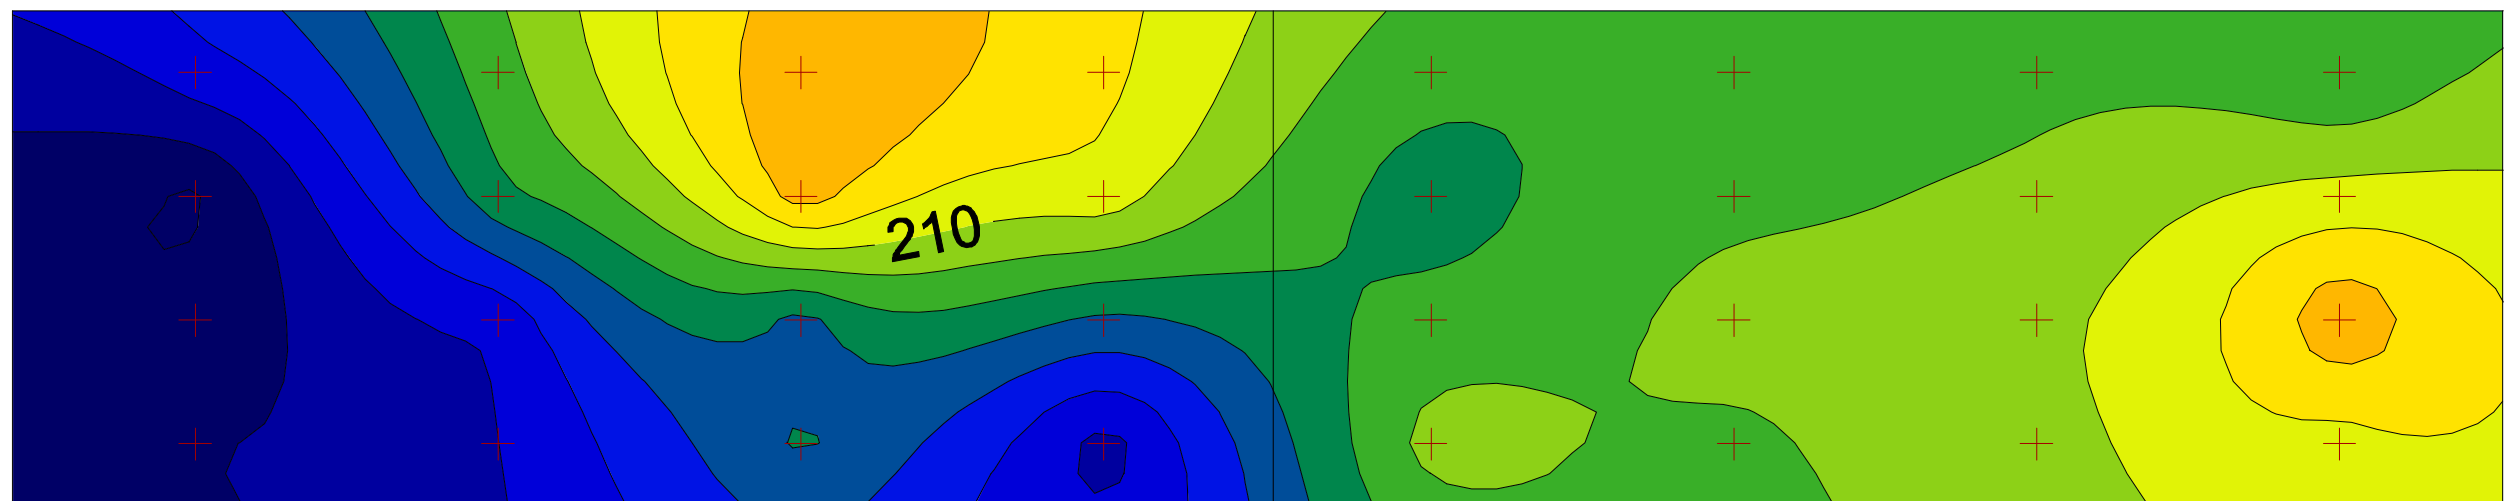
Figure 3

In setting up for the third and final test an attempt was made to remove burners 1 & 8 from service (Burner 1 had no flame stabilizer). However, when the pair of burners was removed superheat temperatures quickly increased to values above 1010 deg F. Apparently, the additional heat input higher in the furnace (fuel displaced from the burners removed from service), was detrimental to already high superheat temperatures. Accordingly, the burners were returned to service. The final tested configuration closely resembled test number 060907-2, with replaced atomizers in burners 22, 27, and 16 as discussed above. Interestingly, it was found that CO levels in the economizer outlet, did in fact level out to some extent. While the values were still relatively high, North and South duct averages were found

to be much closer than the previous test runs. It is believed that improvements to the overall distribution were realized by replacement of the above fuel oil atomizers.

It is recommended that the missing and damaged flame stabilizers be repaired as soon as possible. It is also recommended that once the swirlers are replaced, an additional test documenting the new operating condition be taken (This will assist in identifying issues in the future).
